Emergency Stabilization of the Basilica of St. Francis of Assisi

This paper describes the damage caused by the 1997 earthquakes and aftershocks to the Basilica of St. Francis of Assisi and the urgent measures executed to stabilize the structure. The studies utilizing many mathematical models and analyses to design the seismic retrofit and restoration will be presented in a paper in a second disaster preparedness issue of *CRM* scheduled for publication next year.

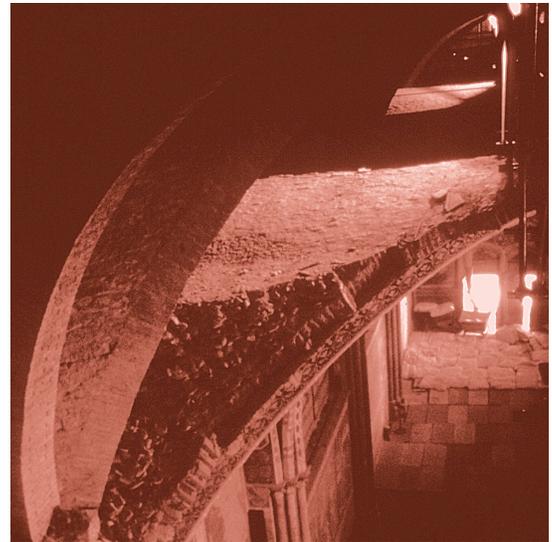
Concerning the vaults, the collapse was produced by a large volume of fill which was mainly broken roofing tiles and other loose materials accumulated over centuries of roof repairs in the

The fill accumulated through the centuries over the vaults.

springer zones. During earthquakes, this non-cohesive fill alternatively acts only in one direction because there is no connection in the opposite direction. In addition, the loose fill follows the movement of the vaults, opposing their recovery and facilitating increasing permanent deformations. When the quake of September 26 hit the basilica, it is very likely that there was already some permanent deformation, reducing the curvature and, therefore, the bearing capacity as the result of previous earthquakes.

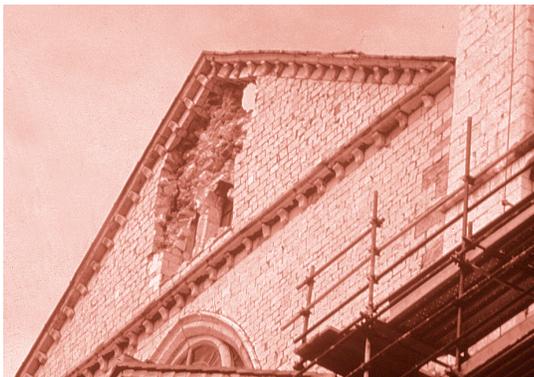
Besides the differing impact that the many historic earthquakes of different characteristics may have produced on the basilica, other factors have increased the vulnerability with respect to the past. Concerning the tympanum, constructed of a cavity wall with two faces and an inner fill, the cause of the partial collapse was the deteriora-

tion of the mortar which connects the stones of the external face with the inner fill (the first damage was produced on September 26, but it was the quake of October 7 which created a large hole in the wall). The reduced cohesion and bonding of the deteriorated mortar resulted in progressive failure of the wall stone by stone.

Damage in the tympanum on October 7, 1997.

After some attempts hindered by heavy rain and wind, the crane succeeded in lifting the steel tympanum over the brackets. The following day the empty spaces and larger holes were filled with polyurethane foam to provisionally stabilize the masonry.

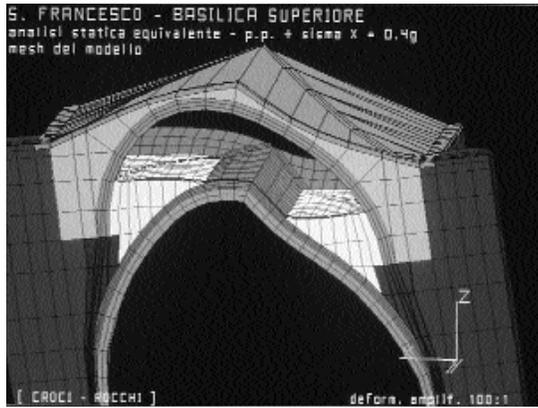
Deformations of the vaults produced by the fill.

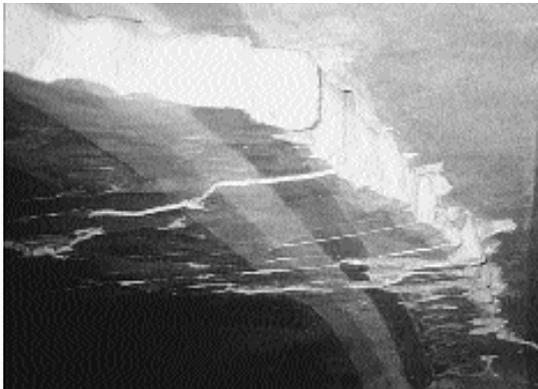
Large cracks in the vaults with relative movements of around 25 cm.

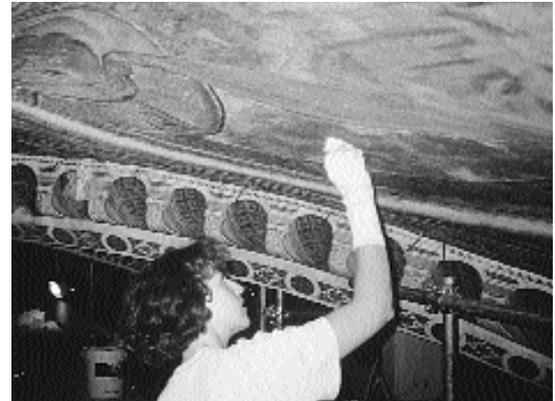
Cracks and loss of curvature of the ribs.

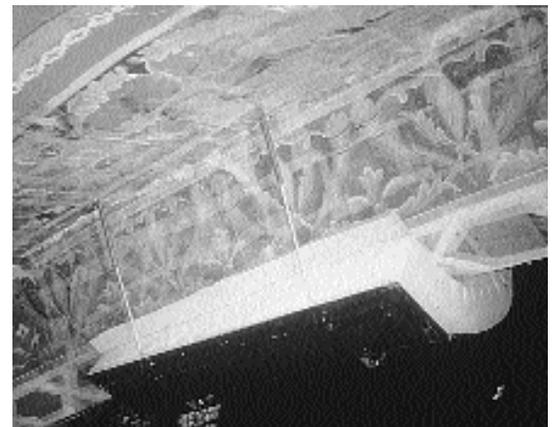
Suspension of the deformed kerbs (restraining straps) to the roof.

- Applying bands of synthetic fibres over the cracks of the extrados;
- Suspending the vaults from the roof framing with a system of tie bars, having first inserted two springs to maintain the force at the design value, independent of thermal effects and minor vibrations; and
- Suspending the ribs from the roof with a system similar to the previous one after having placed a kind of steel cradle filled with soft rubber underneath in order not to damage the frescoes.
