# Stabilization and Restoration at Russell Cave

John E. Ehrenhard

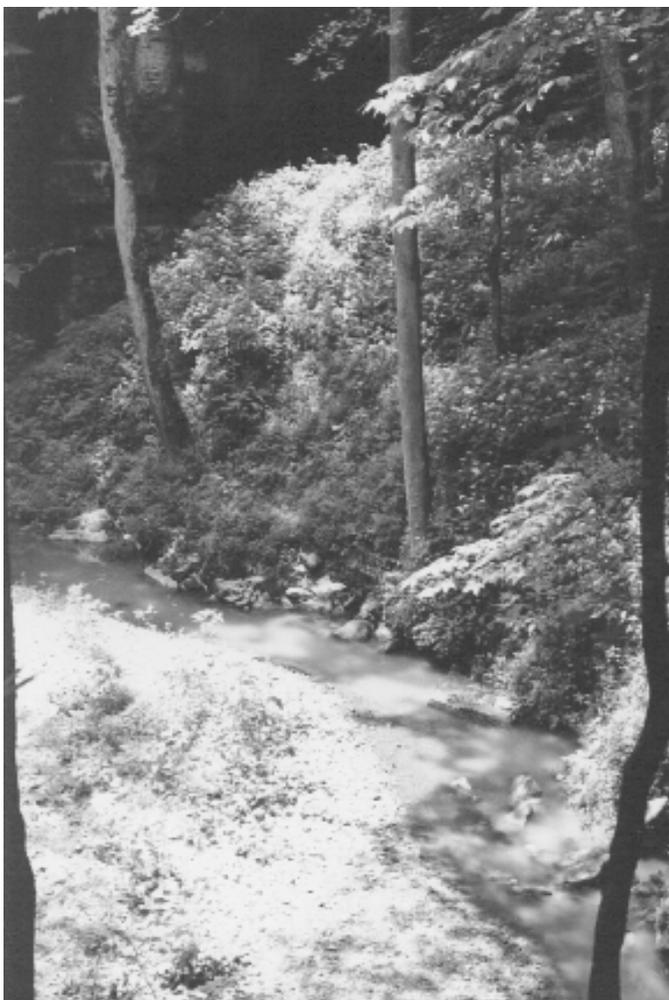
In the past few years as much as eight feet of debris, rocks, and sand from upstream have been deposited in the Dry Creek stream bed within Russell Cave's boundaries. The increased silt deposits, created through poor land management practices in areas surrounding the park, have changed the stream flow near the cave and caused serious undercutting of the protective talus pile at the cave entrance. In 1989, the talus slope began to slump and stabilization measures were necessary to reinforce the embankment area (McDade 1992). These measures, however, were temporary. By the spring of 1992, stream bank erosion at the base of the talus slope had become so serious, there was concern for the integrity of the cave and its cultural deposits (figure 1). Erosion at the base of the embank-

Fig. 1. Erosion at the base of the cave embankment. Notice position of stream in relation to the two large unprotected trees that are in danger of being dislodged. Cave entrance is visible in upper left-hand corner of the photo.

ment continued to expand with each succeeding rain storm.

Archeological site stabilization specialists from the Interagency Archeological Services Division (IASD) of the National Park Service along with Tennessee Valley Authority civil engineers visited Russell Cave and agreed that to save this valuable portion of our heritage, stabilization of the talus slope in front of the cave entrance was vital. However, stabilization demanded more than simply an engineering solution. We knew it would be unacceptable to undertake a treatment that altered the spatial character of the landscape. By studying old photographs and documents, we felt we could accurately duplicate the eroded historic vista by rebuilding the entire landscape out of local materials. We decided on a stone bulwark using immediately available river gravels, sands, and rock.

After preparing the access, the D-4 used its blade to remove and reposition a depositional island of coarse rock, sand, and silt that had built up at the cave entrance. The formation of this island, precipitated by previous flooding, was the primary cause of the realignment of the stream against the toe of the slope. The material in the island was pushed up the face of the talus slope. This material served as the substratum for the stabilization effort. Because it filled up the many voids and crevices in the slope, it also served as a leveling mechanism. Next, a channel was prepared approximately three feet below the water line along the base of the talus pile. This trench traversed approximately 150 linear feet. The excavated sands and gravels from this channel were also pushed up the slope.

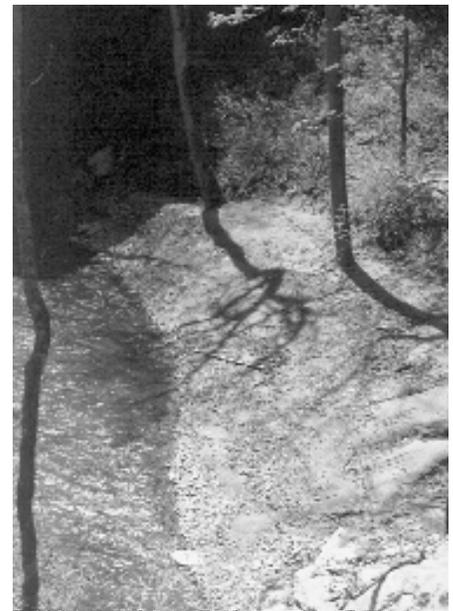
Fig. 4. View of completed bulwark. Compare with Fig. 1. Notice reconfiguration of the stream and position of the two large trees. Cave entrance is in the upper left-hand corner of the photo.

layer was no less than 6’ thick at the base and gradually tapered to approximately 2’ thick at the top (figures 3 and 4). As a final measure, to help insure the security of the bulwark, the bulldozer angled its blade and dug out a new stream channel, which, in fact, turned the water course away from the embankment and returned it to its historic location.

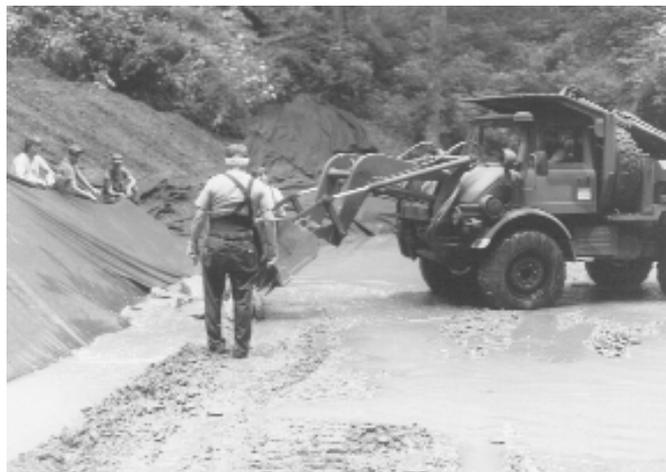
Fig. 2. Primary panel of filter fabric being stretched out. Base of the fabric is anchored in the channel seen in the lower left-hand corner of the photo. Rocks are being placed over the fabric to firmly anchor it in the channel.

After some minor “landscaping” of the substratum, a heavy-gauge 15’-wide filter fabric (Mirafi 140-N, purchased by IASD) was rolled out over the bedding material (figure 2). The fabric was laid down like shingles on

a roof. Approximately 60% of the first and lowest panel was set underwater in the channel that had been prepared at the base of the slope. The second and third panels were then placed in a step-like manner, moving up the slope and leaving at least a 5’ overlap.

With the filter fabric in place, the National Guard began working in earnest. They used their equipment to move large granite boulders (500–2,000 lbs.) on top of the filter fabric already placed in the channel. This provided the anchor and the foundation for the bulwark construction. Once the channel was filled, additional large boulders were placed as riprap (Russell Cave NM had purchased and stockpiled 100 tons of riprap from a local quarry) up the face of the filter fabric. Creek bottom sediments were spread over the top of this large riprap, filling in all the voids and naturally cementing, or bonding, the riprap in place.

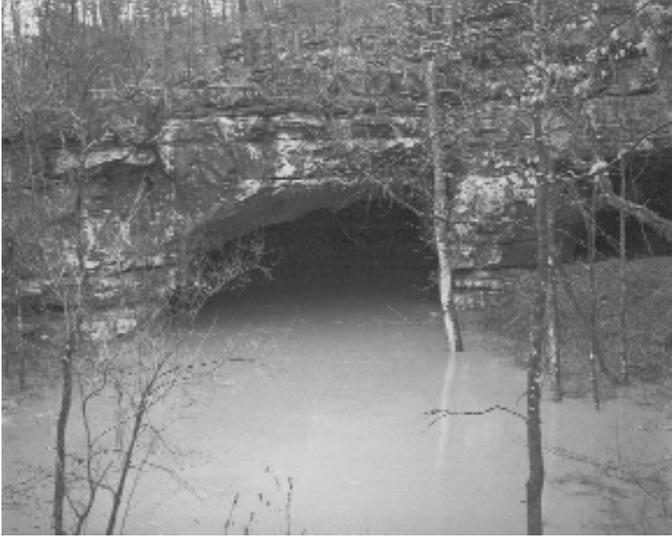
In March 1993, excessive accumulation of snow and extremely heavy rains provided the first good tests of the bulwark. Heavy flooding breached the banks of Dry Creek, and high water inundated much of the low-lying areas of Russell Cave NM for several days (figure 5). When the water receded, study of the bulwark revealed

Fig. 5. View of cave entrance during March 1993 flooding. The two large trees provide reference points.

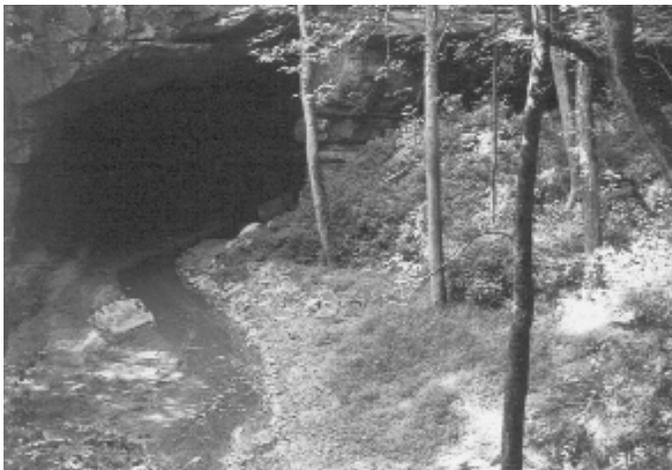
that it was unaffected. Throughout the late spring and summer months of 1993, volunteer grasses and bushes sprang up rapidly (figure 6), conveying the same visual appearance of the landscape prior to slumping of the talus slope.

Fig. 6. Bulwark in September 1993. Compare with Fig. 4. Notice growth of grasses and bushes.
