Protecting the Messages on el morro

A multi-year project is underway at El Morro National Monument in west central New Mexico, to document and preserve historic writings and drawings on the face of the rock. The work is being done by the Southwest Regional Office of the National Park Service, with assistance from the University of Pennsylvania through a cooperative agreement.

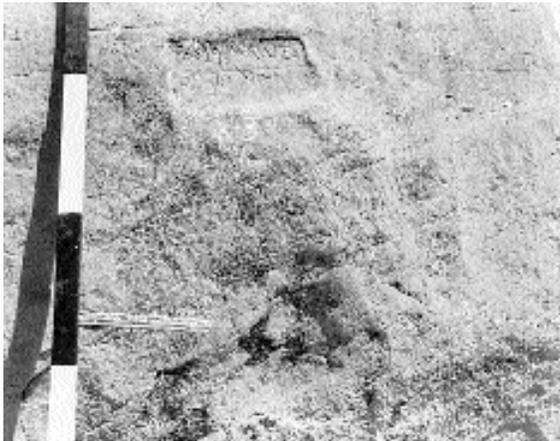
Top photo: Pablo Morales inscription in 1955.

The next phase of the project was to photograph every inscription (precisely replicating, where possible, the photographs from 1955) and to conduct an assessment of their condition.

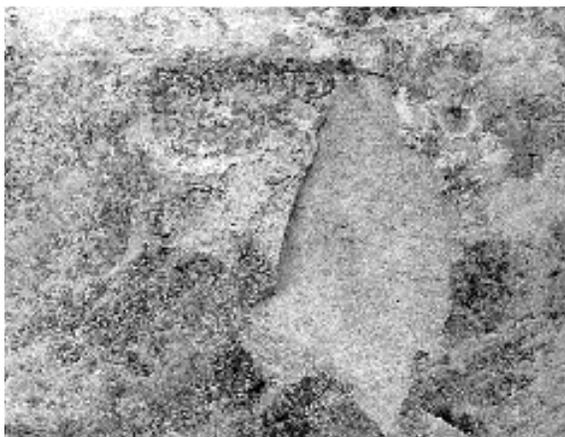
Bottom photo: Pablo Morales inscription in 1992. By 1994 this inscription had further deteriorated, and was nearly gone.

Where one or more of the above listed conditions was identified on the inscriptions, it is outlined on the photos. Based on this new knowledge of conditions and causes, a priority rating was assigned to each inscription or section of wall: from 0, which means that the section is stable and there is no apparent threat, to 6, which means that the section is very unstable and its inscriptions or rock art are in danger of imminent loss.
