Conservation of a Yellowstone Studebaker Wagon

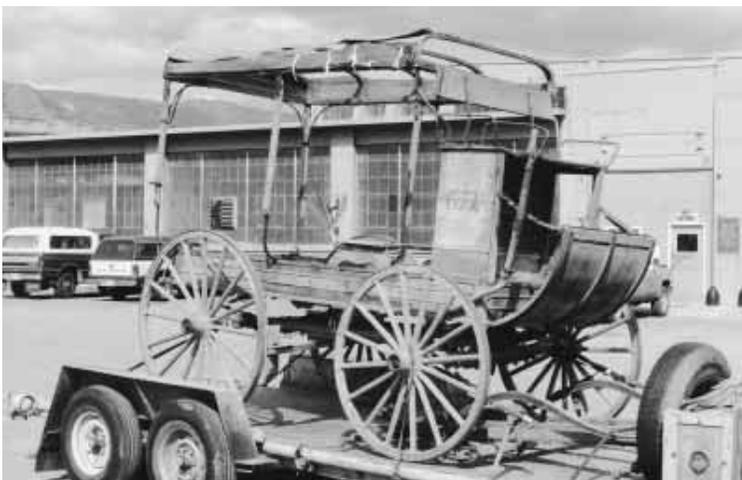
Shaw & Powell buggy, before conservation, being loaded for transport to conservator's workshop in Cody, Wyoming, 1997. NPS photo.

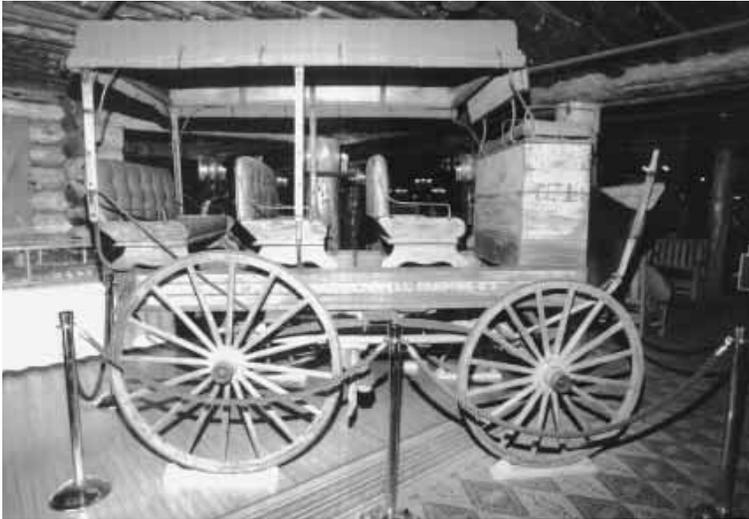
Shaw & Powell buggy—after conservation—on display in the Old Faithful Inn Lobby, summer, 1998. NPS photo.

The conservation/restoration of the vehicle was performed locally over a period of six months, and entailed stabilization as well as wholesale replacement of missing elements. Described and photodocumented in a final report, treatment included rebuilding most of the top of the wagon and replacing the left side-panels of the driver's box and the driver's footrest. A set of side springs, correct for this vehicle and from the same time period, was located near Helena, Montana and installed on the wagon. The original front springs were re-arched to match the side springs. Original seat parts, found lying on the floor of the wagon, were combined to create one complete seat. The two other passenger seats, all of the leather upholstery, the front leather boot, and the side curtains are historically accurate reproductions of the originals, based on archival photographs and Studebaker catalog illustrations. The seats were stuffed with a rubberized hair product recommended by HFC in place of the excelsior with which the seats appeared to have been originally filled. The iron tires of all four wheels were tightened, but required no other treatment. Pigmented microcrystalline wax may be applied to the wagon's ferrous metal elements at a later date.
