Conservation vs. Disasters

The Restoration of Kathrineberg

The restoration of Kathrineberg, the historic residence of the governor of the U.S. Virgin Islands, has been described by specialists as the most advanced project of its kind in the Caribbean.

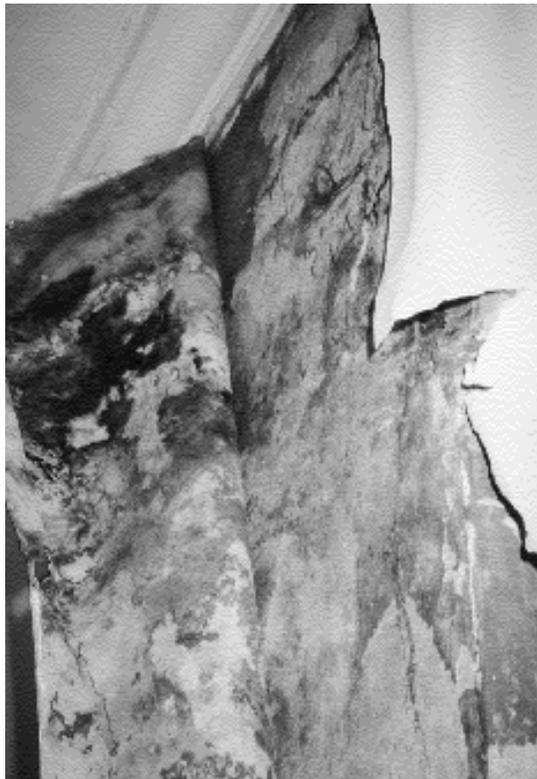
Inside the house in the central corridor immediately beneath the cracked and leaking gutter (see next photo) the wallpaper over a doorway was found to be peeling off the wall, with a massive fungal attack growing on the soaking wet wall paper paste and animal protein glues of early distemper paints.

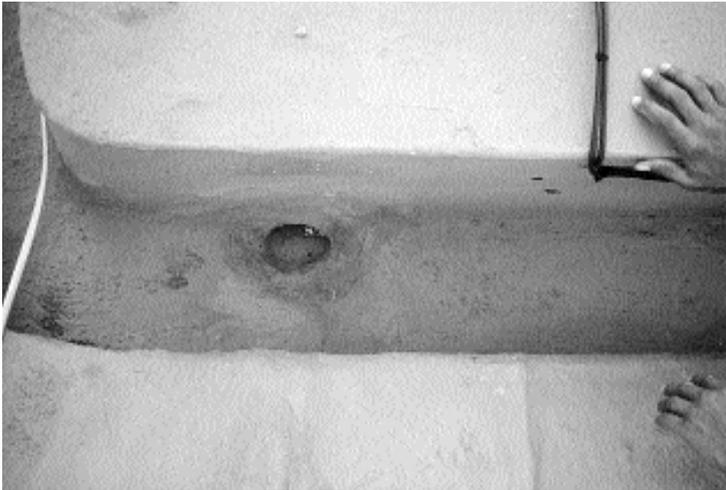
Painted many times, the corroded galvanized steel roof had many leaks. Here a gutter is cracked and leaking badly next to a critical rainwater outlet. The outlet was one half the size that it should have been. This causes overflowing and even worse leaks during tropical down-pours.

The process of conservation and restoration first involved the total replacement of a highly corroded and leaking galvanized steel sheet roofing of recent origin. It was replaced with a carefully detailed malleable stainless steel sheet roofing, a substitute material designed to last in this harsh maritime environment with its frequent tropical storms and hurricanes. Before the interior restoration had been finished, the new roof had already withstood Hurricane Floyd (1999) and a major tropical storm with torrential rains. Concurrently with the work on the roof, the project continued with the sealing-off of room after room of the interior and removal of damaged modern drywall so that the thick masses of fungal organisms could be sprayed with carefully selected chemicals by operatives working in hermetically-sealed protective suits and respirators. Infected material was carefully removed as bio-hazardous waste. Guidelines for removal of the waste generally followed those established by the New York City Department of Health and the American Industrial Hygiene Association.

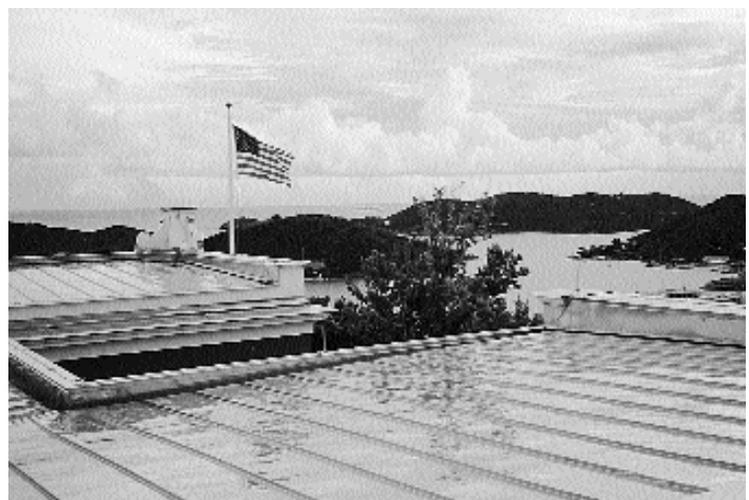
New stainless steel sheet roofing with complete cap flashings on all parapets and roof ornaments. Note new lighting protection system. All rainwater drains have been doubled in size.

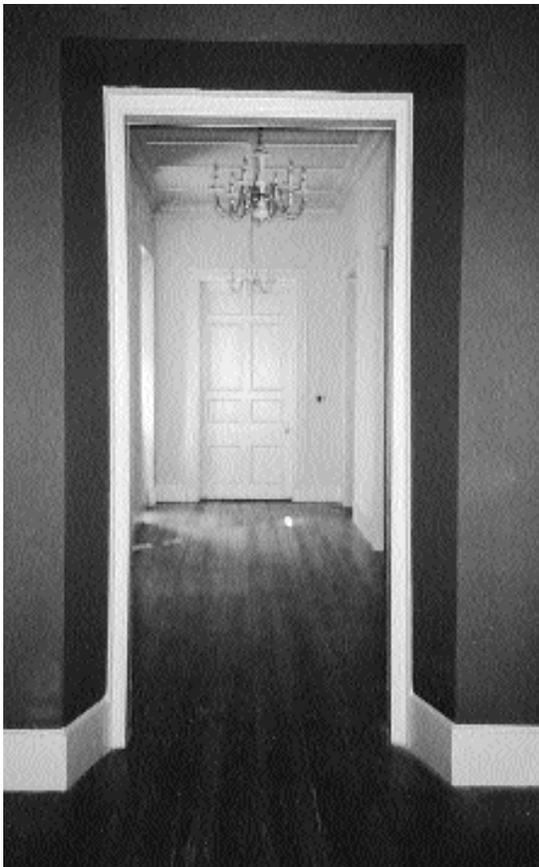
Less than a year later, after the installation of new roofing, the interior is fully restored. The fine timber beams and flooring were restored using the same pitch pine that was originally used. The colors and distemper paint finishes are precise reproductions of the originals from the 1830s.

Taking another lesson from the building, the writer has restored the fine timber beams and flooring using the same top quality pitch pine that was used originally. It was noted that wherever the high quality pitch pine had not been used, the wood had usually been consumed by termites and hence the need for restorations.

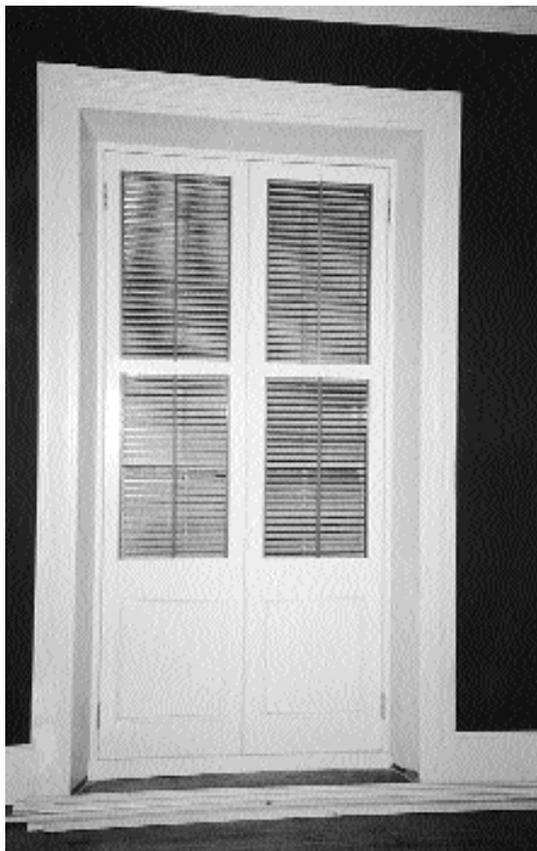
Typical, accurately restored historic jalousie doors that provide natural cross ventilation.

All modern air-conditioning units, which were contributing large quantities of condensation to the walls, were carefully and totally removed. The complete original system of through-ventilation with louvered shutters was then restored. Kathrineberg is well sited on top of Denmark Hill and here the constant breezes are ideal for this traditional ventilation system. This restoration also makes excellent sense because it does away with the need and expense of constant air-conditioning.
