Charleston Photogrammetry

Mellonee Rheams
Tom Behrens

HABS, in cooperation with the Historic Charleston Foundation, undertook a documentation project of the Battery. The project was initiated in the summer of 1992 to produce a photogrammetric and photographic record of the streetscapes along the South and East Battery in Charleston. These homes are considered the most vulnerable of the city's historic resources. This documentation is intended to provide a baseline documentation for catastrophic replacement.

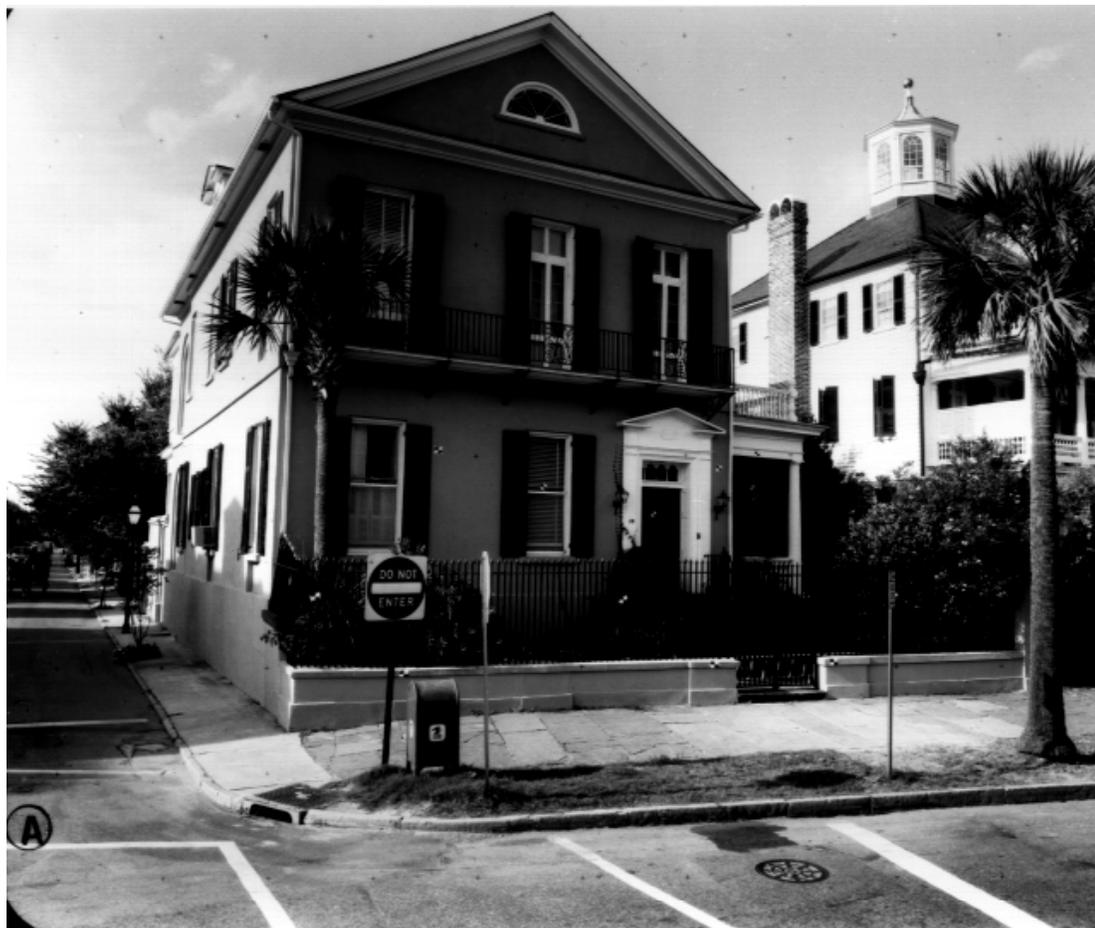
No. 34 South Battery, Charleston, SC. The photos illustrated give an example of the two different types of houses photographed 1) #34 South Battery represents a simple facade with a minimum amount of foliage compared to 2) #29 East Battery which was complex and foliage was a major factor that had to be considered when photographing. Please note the reseau grid (a pattern of cross hairs) superimposed on the photo image, the black and white Xerox targets placed randomly on the structure, and the different camera stations used. Photo by Jet Lowe, 1992, HABS.

The modus operandi for field work was to establish two datum points at a known horizontal distance and place random targets on the remainder of the house or in the field of view as common reference points to aid in the digitizing process. The datum points that were placed on each facade had to be carefully measured, as this was the most critical component within our survey control data. The survey control data (field notes), used as reference information, includes datum point locations, measurements, and different camera stations. One of the initial challenges that we were presented with was accessibility to the structures to place targets that were necessary for the digitizing phase of the photogrammetric process. The targets were placed either by the use of a

Although the facades can usually be photographed from a minimum of 3 camera stations, the complexity of some of the facades required that we photograph them from 4-10 stations in order to ensure adequate coverage. In photographing a structure, many natural and man-made obstacles present limitations on obtaining the clear, clean images needed for the photogrammetry process. Those obstacles, combined with the relative complexity of the architecture, dictated the number of view station points and angles needed to adequately document a facade. Foliage and automobiles were the two major obstacles with which we had to contend. In these instances it was common that the amount of angles and view points would double or triple in order to ensure adequate coverage. One of the most beneficial techniques we employed was to use a "cherry picker" to shoot aerial views of the facades, which removed most of the foliage and showed the roof and upper portion of the facades in greater detail. Sun location and the weather also dictated

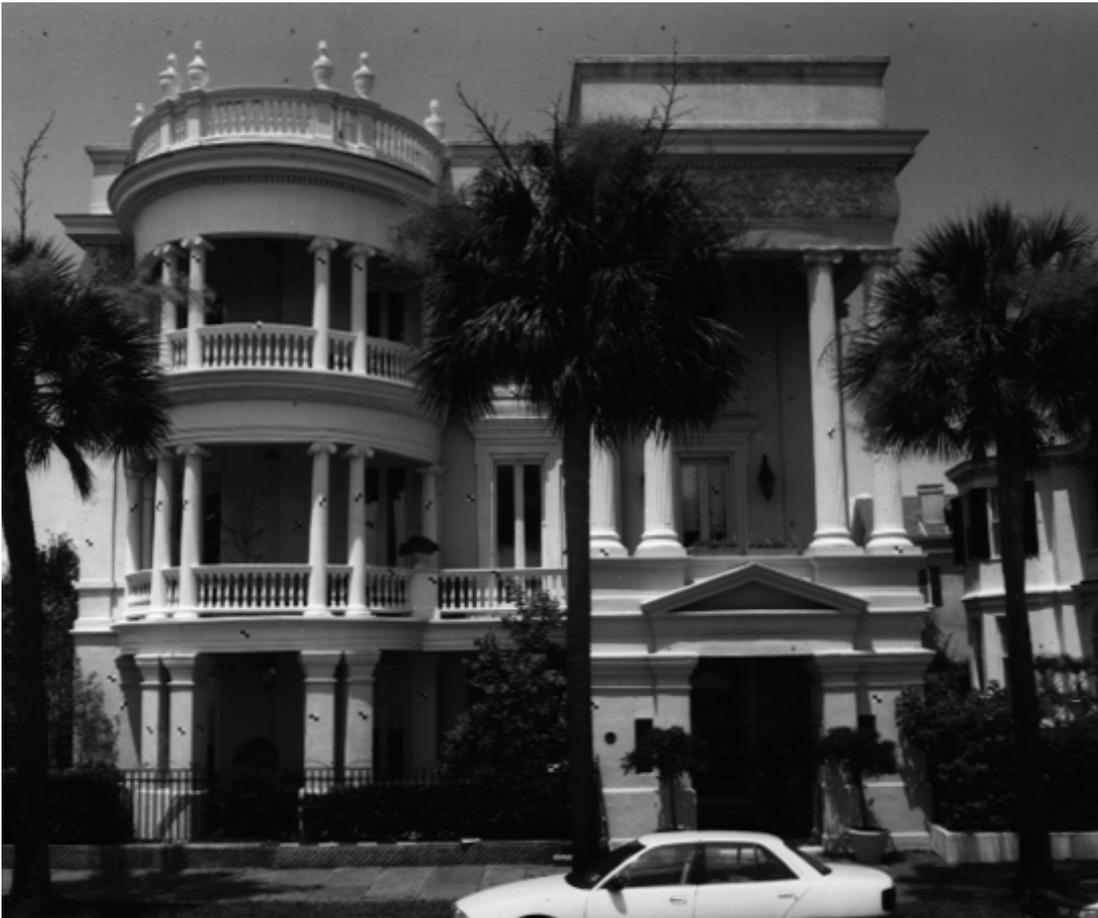
No. 29 East Battery, Charleston, SC. Photo by Jet Lowe, 1992, HABS.
