# Conservation Treatments for the Washington Monument Commemorative Stones

## Using Guidelines

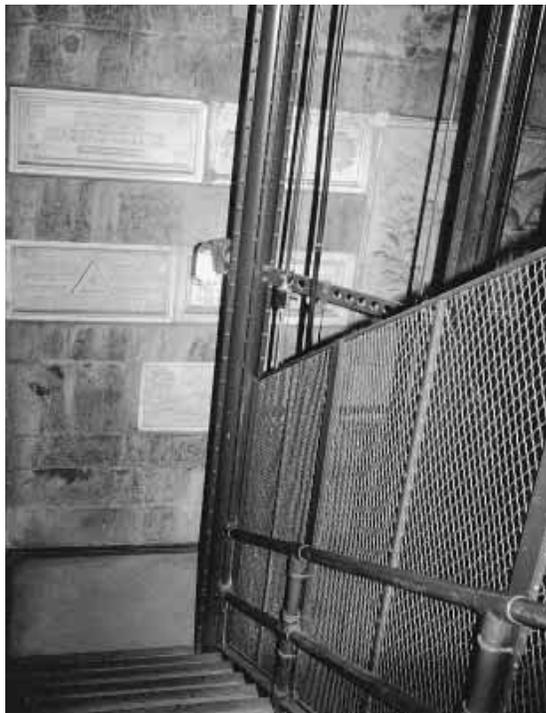
*Washington Monument Commemorative Stones on the 140-foot level. Photo courtesy Naomi Krall, NPS.*

The condition of the stones at the beginning of the project has resulted from a period of time in which the stones have been completely exposed to the elements and subject to poor environmental conditions. This is evidenced in eroded and flaking surfaces, and also some cracks and fractures. Stones have also been vandalized by graffiti and removal of projecting pieces, and many stones have been scarred with misguided graffiti removal efforts. Previous cleanings have left abraded surfaces. In previous restorations,

many missing elements were replaced with epoxy fills that have now yellowed. Incised letters in some stones were painted for easier reading. All stones are extremely dirty.

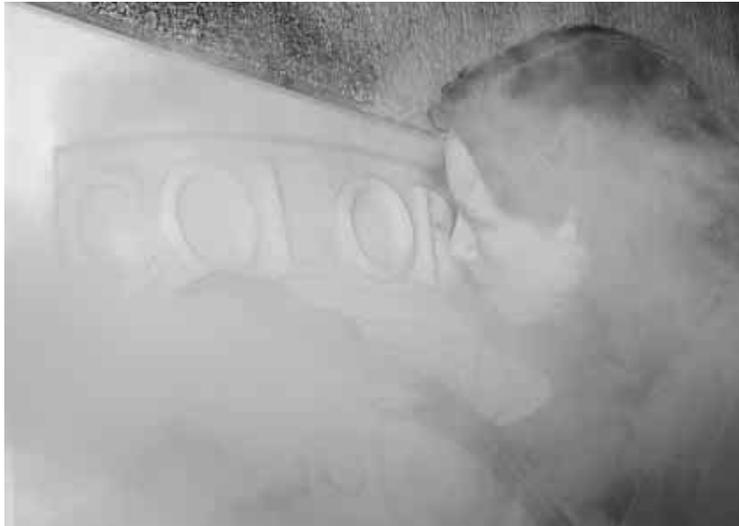
*Conservator steam cleaning the "Colorado" stone. Photo courtesy the author.*

For this project, all stones will be cleaned. If their condition is so fragile that cleaning would cause further deterioration, surfaces will be stabilized prior to cleaning. Cleaning serves two purposes: the first is to remove dirt and grime to restore a clean surface, and the second is to enable the better assessment of condition. Cleaning often reveals problems not visible beforehand. Following cleaning, the condition of each stone is re-evaluated and further treatments are executed if necessary.

The methods and extent of cleaning are guided, in part, by the lack of a water source in the monument. All water is brought up to the work areas on the elevator, and all dirty water is collected and brought down on the elevator; all elevator work must be carried out during hours when the monument is closed to the public. Therefore, cleaning methods use as little water as possible and cleaning is not expected to produce perfectly clean surfaces. For stones that have been marred with graffiti or otherwise stained, more aggressive cleaning treatments are required and great care is taken to ensure well-rinsed surfaces. In almost all cases, non-original paint in letters is being removed. This paint detracts seriously from the aesthetic impact of the stone itself and does not increase legibility to any great extent. Samples of this paint are being saved for future reference.
