# Disaster Preparedness During Construction in Danger Areas

## **Case Study**

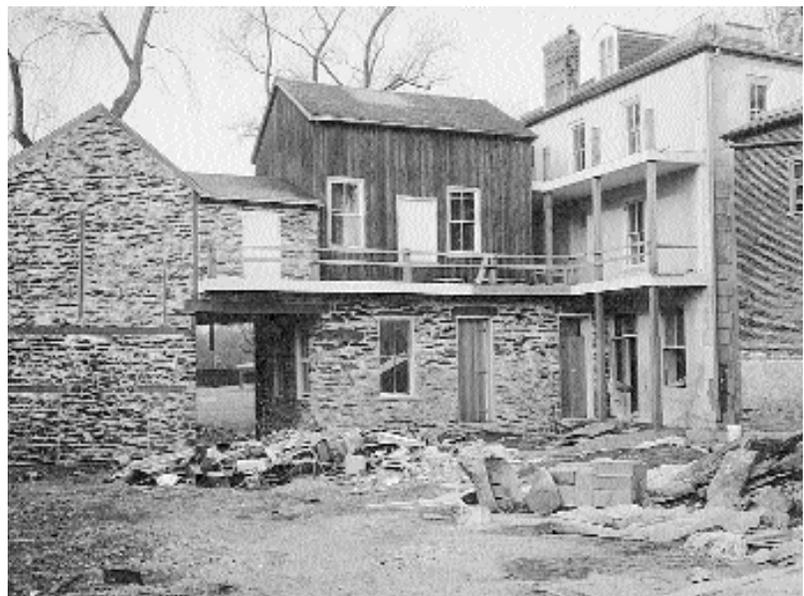
*East elevation of buildings 32 and 33A following the January 1996 flood, looking west. Site debris was deposited as the water receded. The trees behind the buildings were lost.*

After the floods, damage was assessed and clean-up efforts commenced. The contractor's plan was proven effective, as there was minimal damage, the majority of which could not have been prevented regardless of planning efforts. Site landscaping suffered and two 60-year-old trees to the west of Market Street were damaged beyond salvage. Mud and floating debris were strewn throughout the site. Site fencing, custom designed to allow visitors glimpses into the work area, was destroyed in about half of its locations and some small tools were damaged or destroyed. With regard to the buildings, some existing exterior stucco, originally designated for salvage and patching, had to be completely replaced. Inside, some first-floor gypsum wallboard below the five-foot line also had to be replaced and interior plaster walls required patching. Ultimately though, the damage was clearly and significantly reduced as a result of the team's efforts to develop and implement the Contractor's Flood Emergency Response Plan. To cover the costs of lost equip-

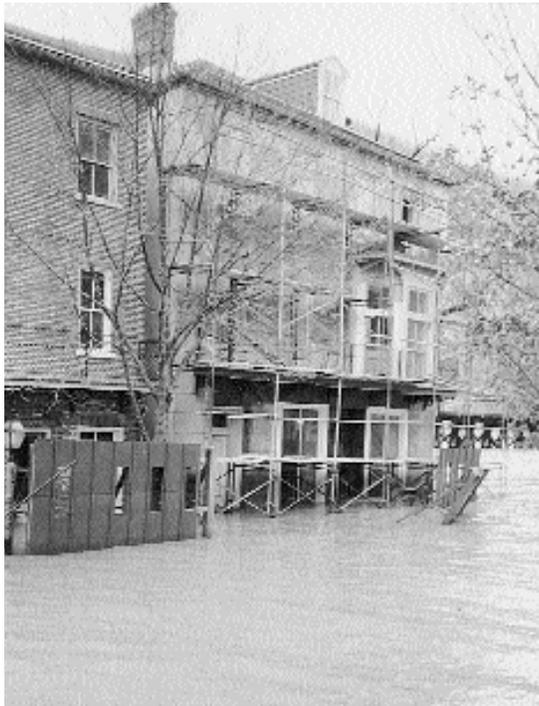
Close-up of buildings 33 and 34 during the January 1996 flood, looking southwest along Shenandoah Street.

The Lower Town of Harpers Ferry was subjected to two significant floods in 1996 during the period of construction (see Noble, p. 16). The first flood was associated with an unusual 36-hour January thaw that melted much of the four feet of snow then on the ground. Water level crested at a height of 29.4 feet, rising approximately five feet up into the first floor of the Lower Town buildings. The second storm, a September hurricane, brought both significant water and wind within a two-day period. For this storm, water crested at 29.8 feet.
